**Report No. CMEC 25-001**  
**LATERAL BEHAVIOR OF LIGHT-FRAME WOOD SHEAR WALLS**  
**ASSEMBLED WITH ELASTOMERIC ADHESIVE UNDER**  
**MONOTONIC AND CYCLIC LOADING**

**Composite Materials and Engineering Center  
Washington State University  
January 20, 2026**

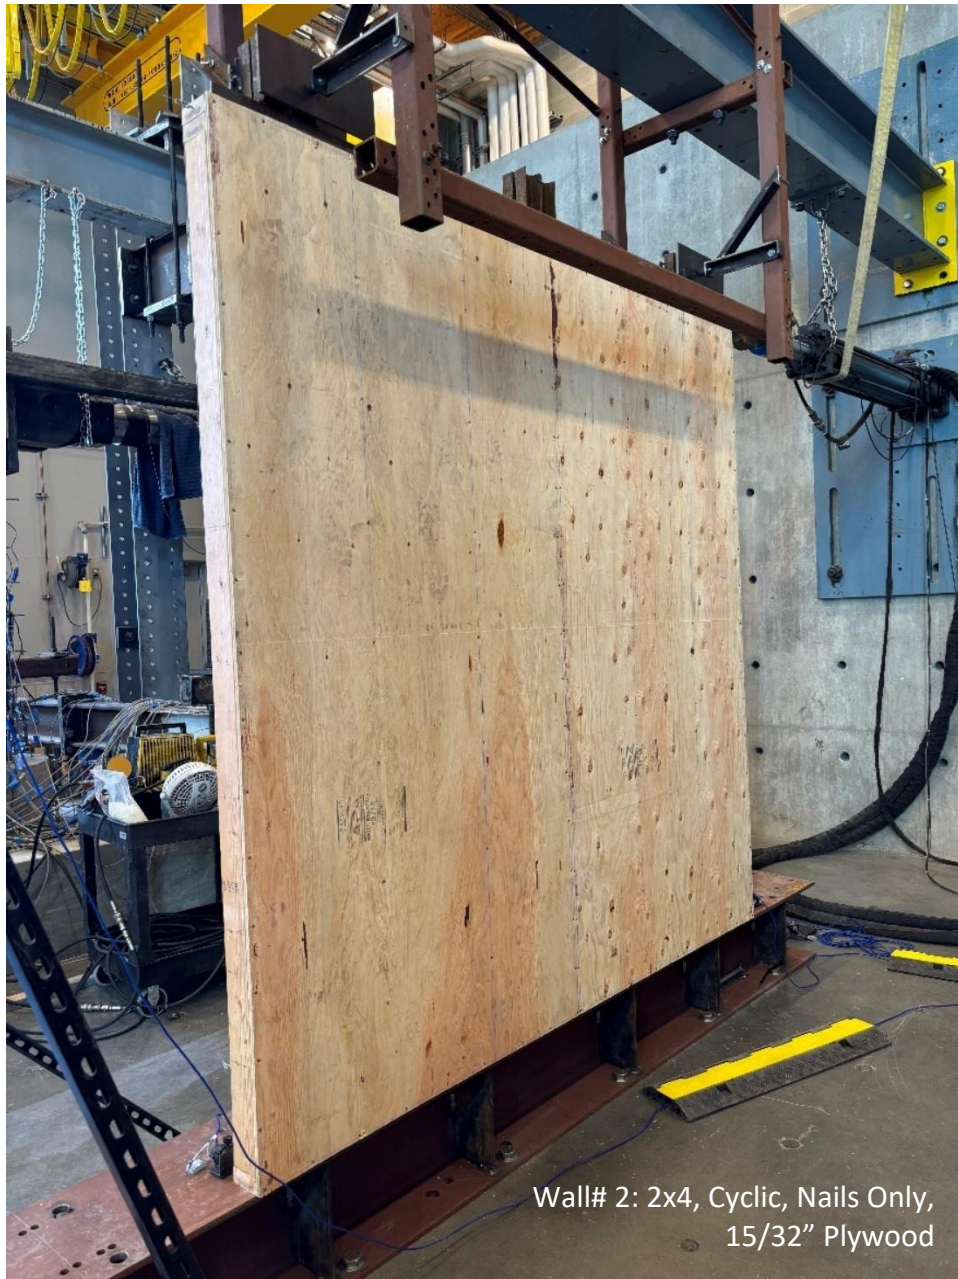
The Composite Materials and Engineering Center (CMEC), at Washington State University in Pullman, WA, performed a series of tests on a light-framed wall with and without the Climate Adhesive product. The tests were conducted according to the guidelines of the ASTM E 2126-19 *Standard Test Methods for Cyclic (Reversed) Load Test for Shear Resistance of Vertical Elements of the Lateral Force Resisting Systems for Buildings*. A typical 8ft x 8ft wall system is shown in Figure 1.

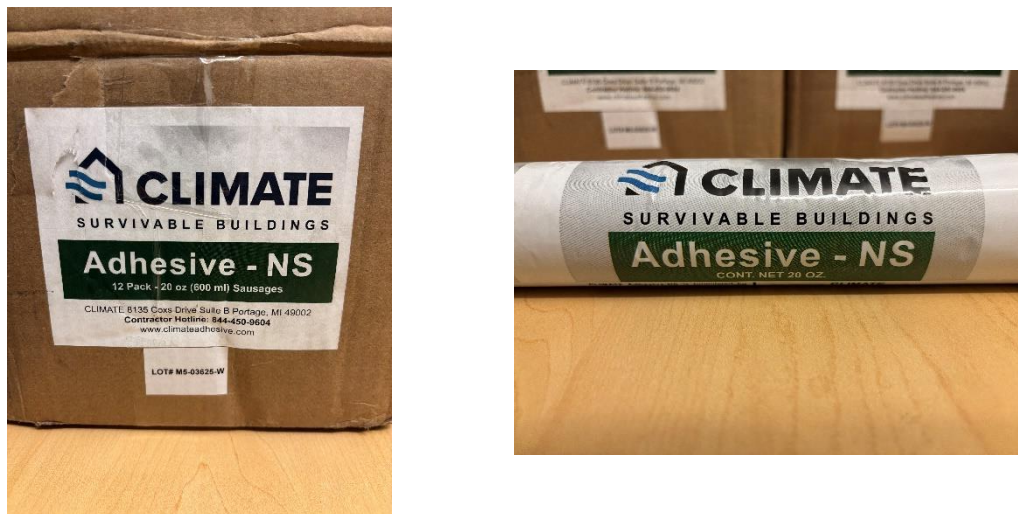
Figure 2. Climate Adhesive – NS.

Climate Adhesive shipped their Adhesive-NS product to the test lab in advance, and was installed by their technicians (on site) during fabrication of the walls. The Climate NS product came in a sausage tube and is shown in Figure 2. The framing nails and sheathing nails used during construction of the walls were purchased locally. The nails used for wood framing construction were a GripRite, bright-coated, 0.131" diameter x 3" long nail, while the sheathing nails were a GripRite, bright-coated, 0.131" diameter x 2-1/2" long nail. A picture of each type of nail is shown in Figure 3.

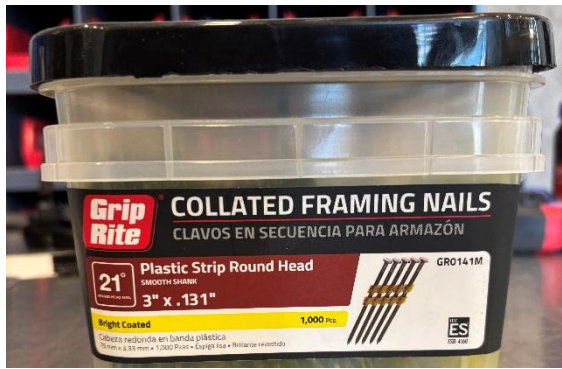
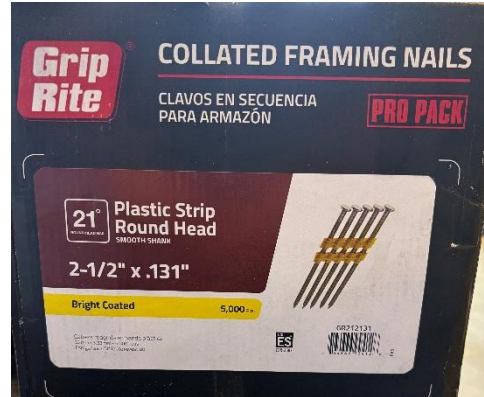
Figure 3. GripRite nails used for the construction of the walls. (a) Framing Nails, and (b) Sheathing Nails.

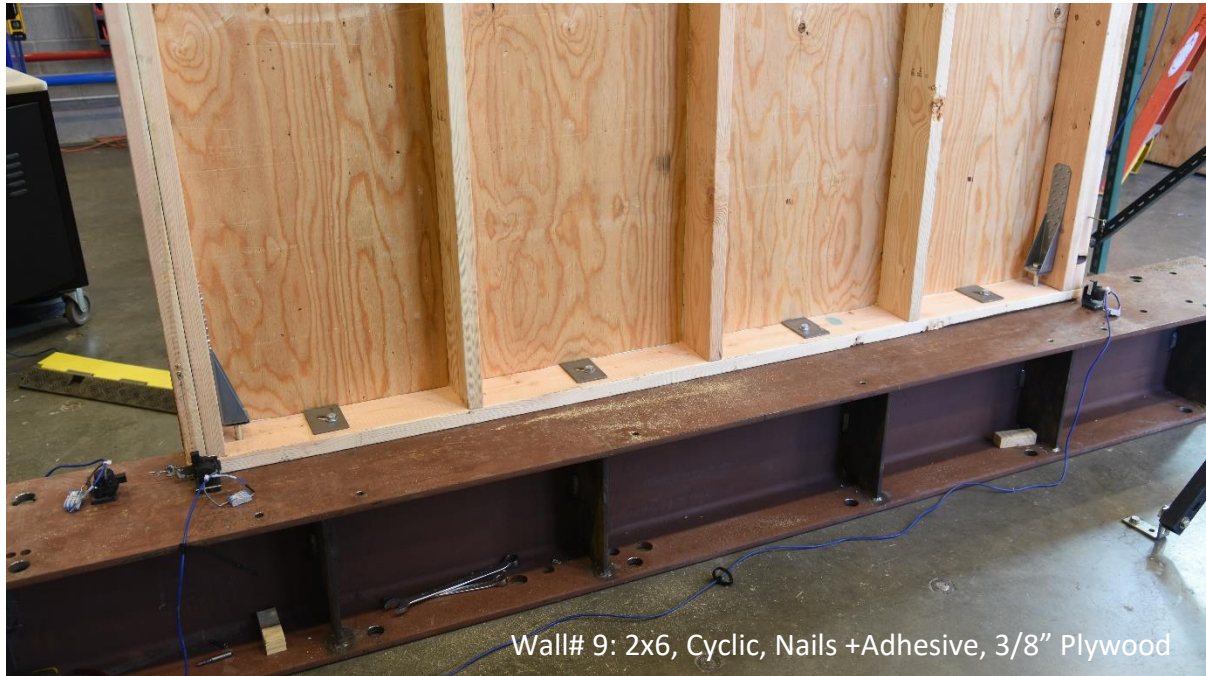
C1. Typical shear wall setup with string potentiometers, bearing plate washers, and hold downs attached to the I-beam fixture in the test lab.

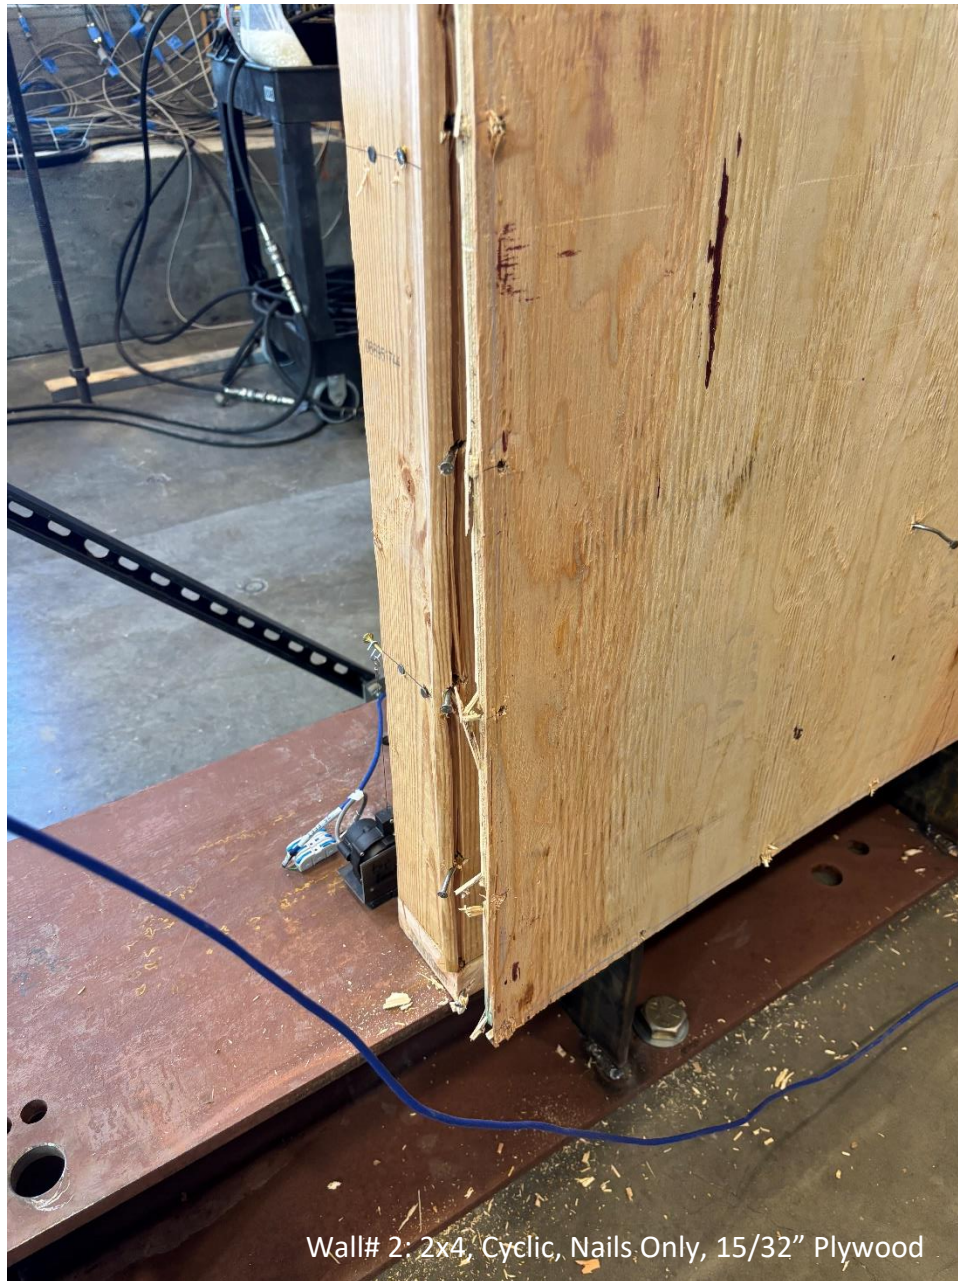
C2. Typical nail withdrawal failure and nail head tear out.

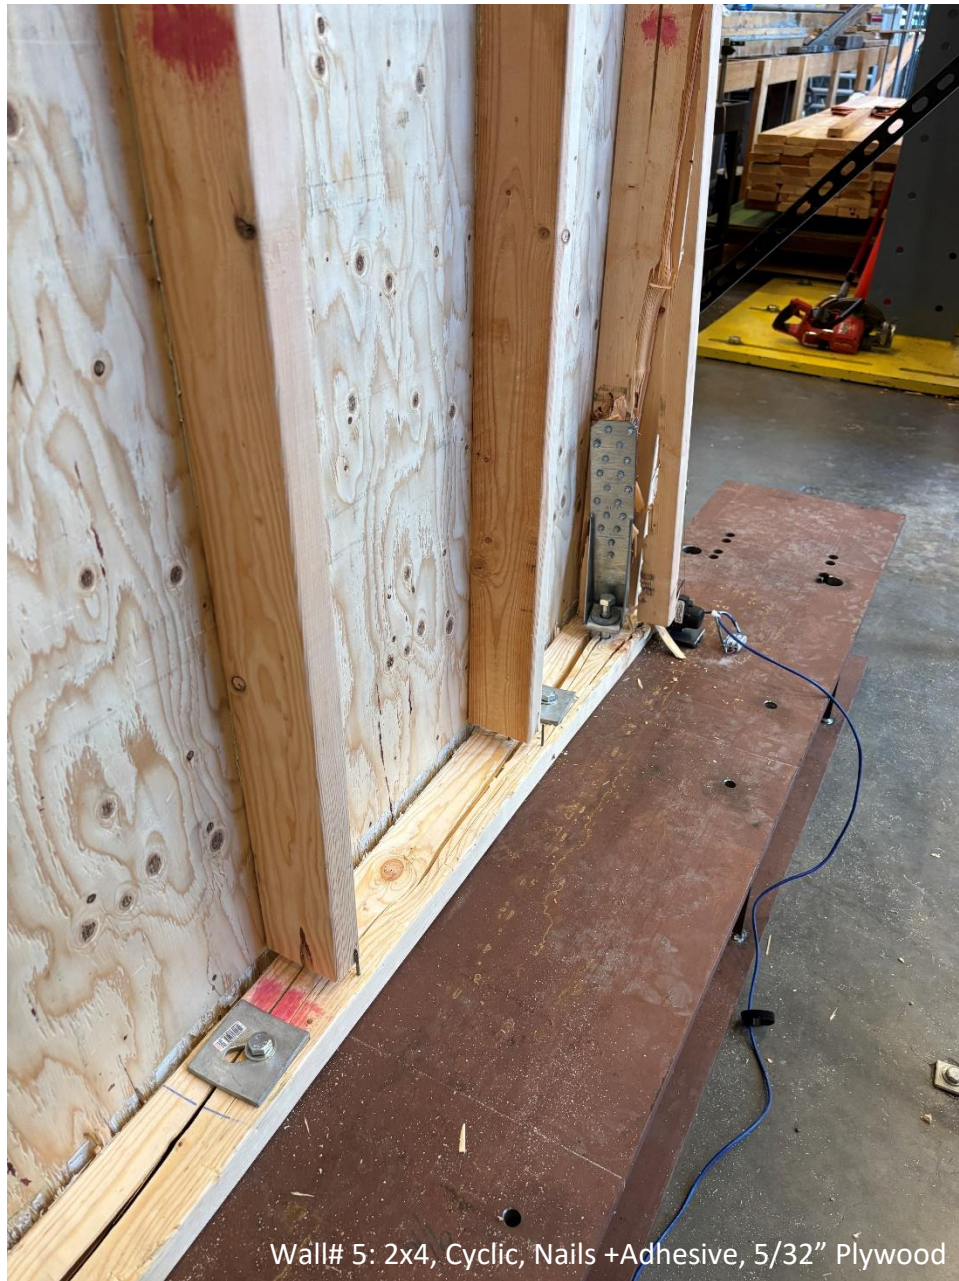
Wall# 5: 2x4, Cyclic, Nails +Adhesive, 5/32" Plywood

C3. Typical sill plate failure and double-stud end splitting – Brittle Failure.

The primary mode of failure for each wall is detailed in Table 10. The adhesive walls had quite a few nail pull-through failures and brittle sill plate, top plate, or double end stud failures. This behavior is attributed to the presence of adhesive at the sheathing-framing interface, which restrains relative slip and rotation between the sheathing and framing. As a result, the nails are prevented from undergoing ductile bending and withdrawal mechanisms typical of nails-only systems. Consequently, a larger portion of the load is transferred directly into the framing members, leading to brittle failure modes.

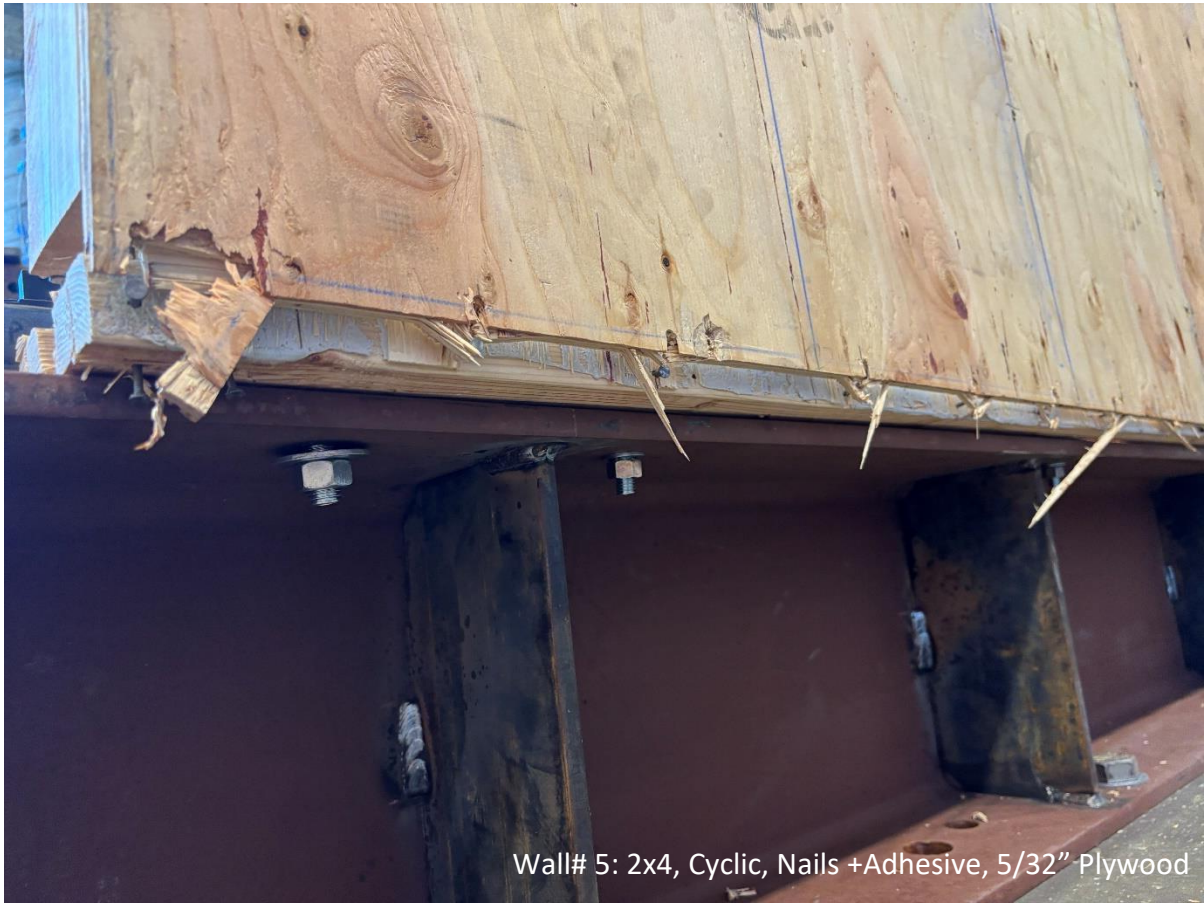
Wall# 5: 2x4, Cyclic, Nails +Adhesive, 5/32" Plywood

C3. Typical glue-line failure.

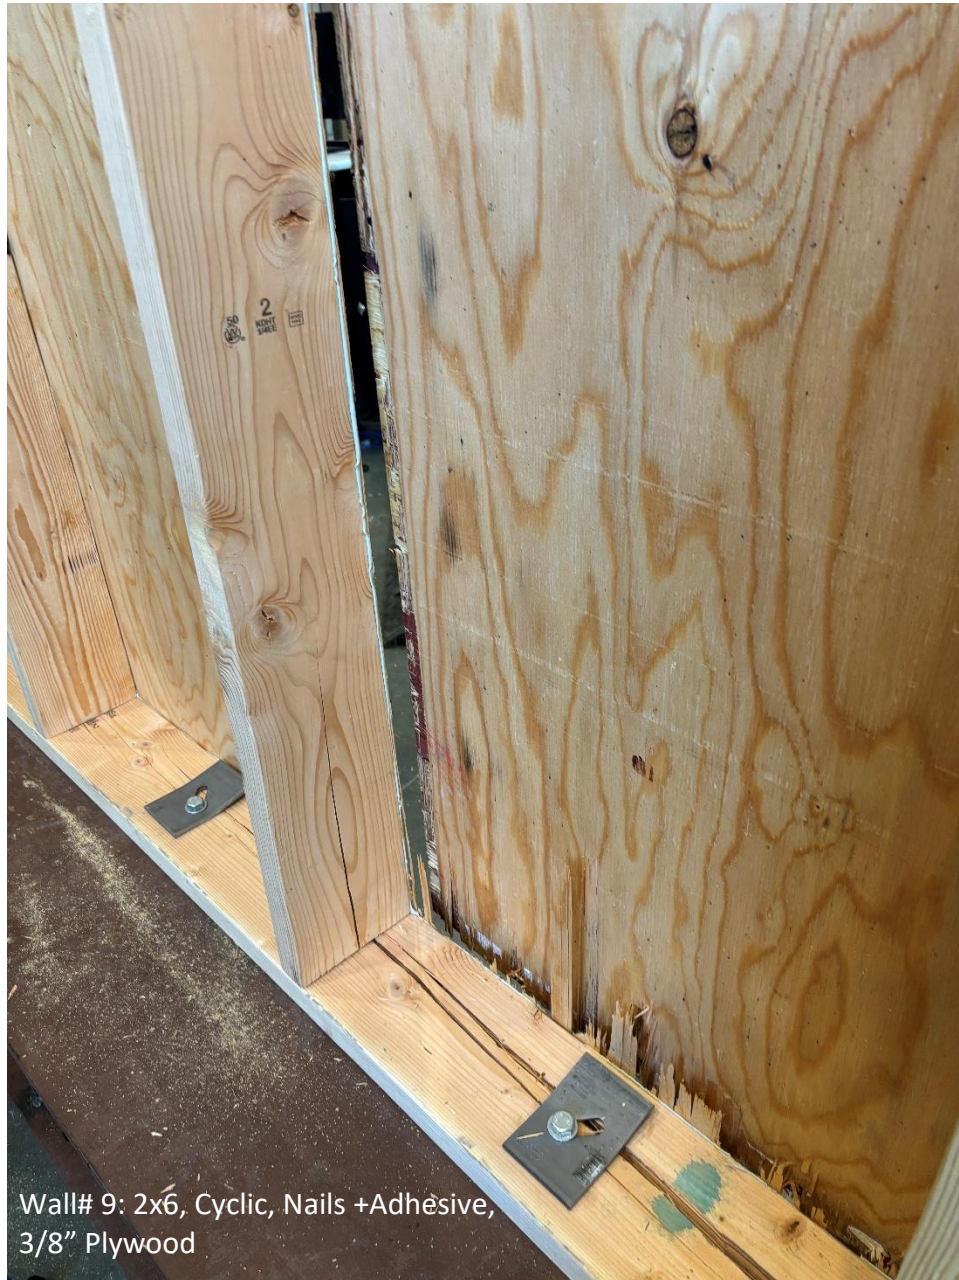
C4. Typical sheathing separation and sill plate failure – Brittle Failure.

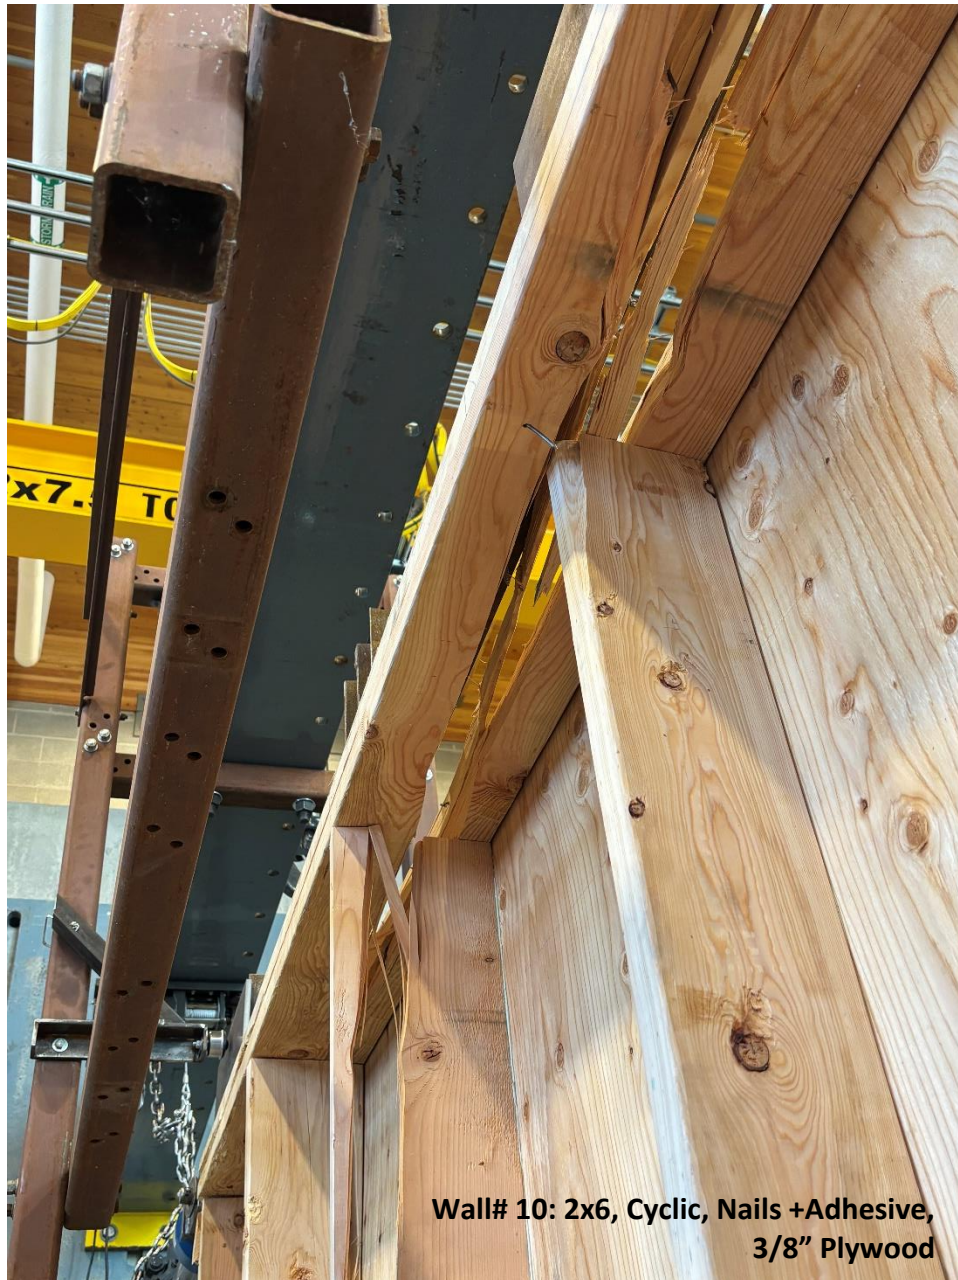
C5. Typical top plates failure (2x6 wall) – Brittle Failure.

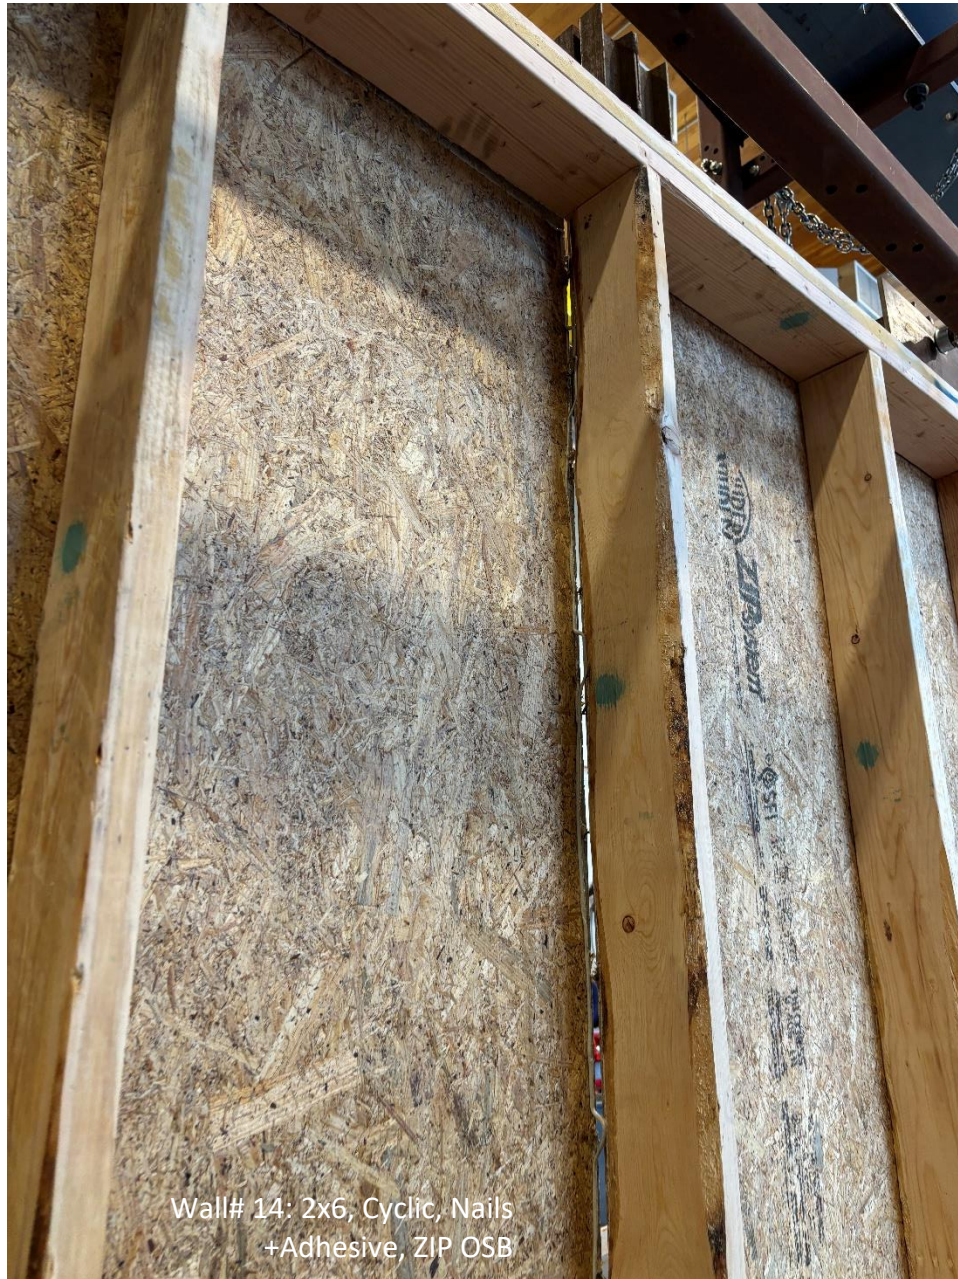
Wall# 14: 2x6, Cyclic, Nails  
+Adhesive, ZIP OSB

C6. Non-typical failure of a glue-line at the center stud (2x6 wall). In this case (Wall #14), the center stud happened to have a lot of wane on the panel joint and provided less area for a full bead bond but did not affect the overall performance.

| Wall ID | Framing Type | Fastening Method | Sheathing Type | Failure Modes |
|---|---|---|---|---|
| 14 | | Nails + Adhesive | ZIP OSB | Nail head pull through at center stud, slight sill plate failure at actuator side and opposite actuator, center adhesive bead not fully adhered. |
